Land use changes and water quality of Sal River in Goa

Bindu Sulochanan, Lavanya, S., Sampath Kumar, G., Prathibha Rohit and Kripa, V.
Mangalore Research Centre of CMFRI, Mangalore

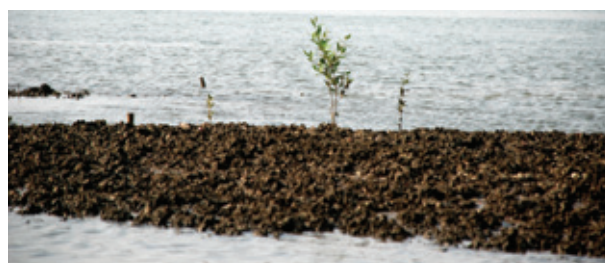
Fig. 2. Oyster shells on river bank

adjacent to Station 2 which is a clam bed area. Shucked oyster shells were also observed on the river bank, on the upfront of which the hotels and restaurants were located. On the banks as well as upstream of the river, litter was observed (Fig. 2).

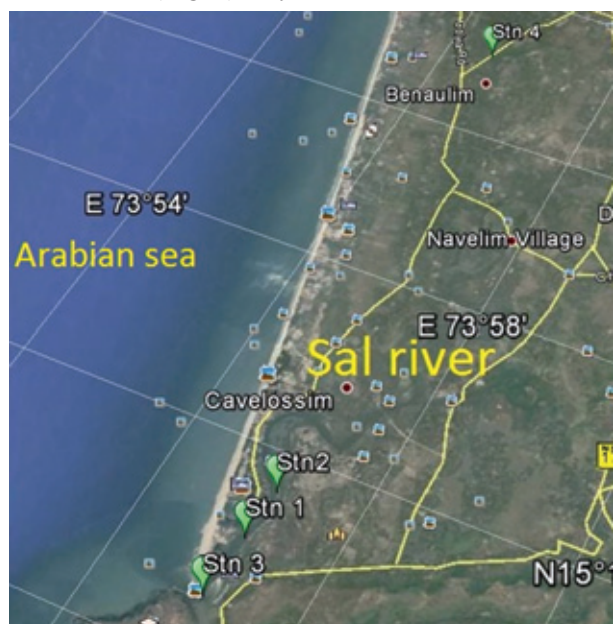
Fig. 1 Sampling locations along river Sal

Based on recent reports of mortality of short-neck clam *Paphia malabarica*, in-situ observation was conducted on 1.5.2014 from four sites along river Sal. The local fishermen stated that the mortality commenced from March 2014. The site where clam mortality was reported is adjacent to Cavelossim and Mobor. Station 1 and 2 are clam bed sites, station 3 is the river mouth opening to the sea, Station 4 is the site where sewage effluent enters Sal (Fig.1). Oyster beds were observed

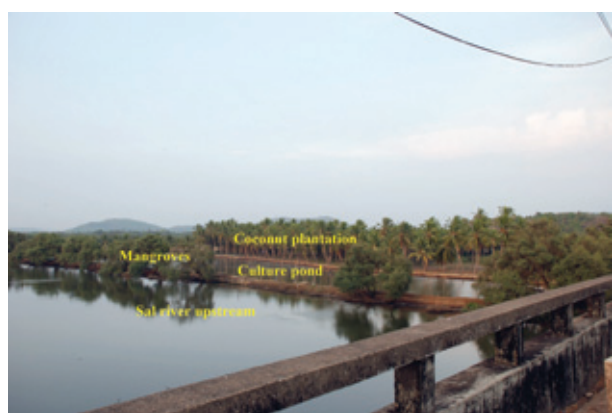
**Fig. 4** Culture pond between mangroves and coconut plantation

The water quality at station 4 which is very near to the sewage treatment plant was observed to be good. Mangroves of fringing type were observed on the banks of river. Its roots prevent litter from reaching the river and also in the stabilization of sediment. This helps in maintaining the water quality of the river. Destruction of mangrove area for culture ponds and coconut cultivation was also noticed downstream of Station 4.
